NASA
Technical
Paper
3370

Studies of Shuttle Orbiter Arrestment System

Pamela A. Davis
and Sandy M. Stubbs

Scale model studies of the Shuttle orbiter arrestment system (SOAS) were completed with a 1/27.5-scale model at the NASA Langley Research Center. The purpose of these studies was to determine the proper configuration for a net arrestment system to bring the orbiter to a safe stop with minimal damage in the event of a runway overrun. Tests were conducted for runway on-centerline and off-centerline engagements at simulated speeds up to ≈ 100 knots (full scale). The results of these tests defined the interaction of the net and the orbiter, the dynamics of off-centerline engagements, and the maximum number of vertical net straps that may become entangled with the nose gear. In addition to these tests, a test program with a 1/8-scale model was conducted by the arrestment system contractor, and the results are presented in the appendix.

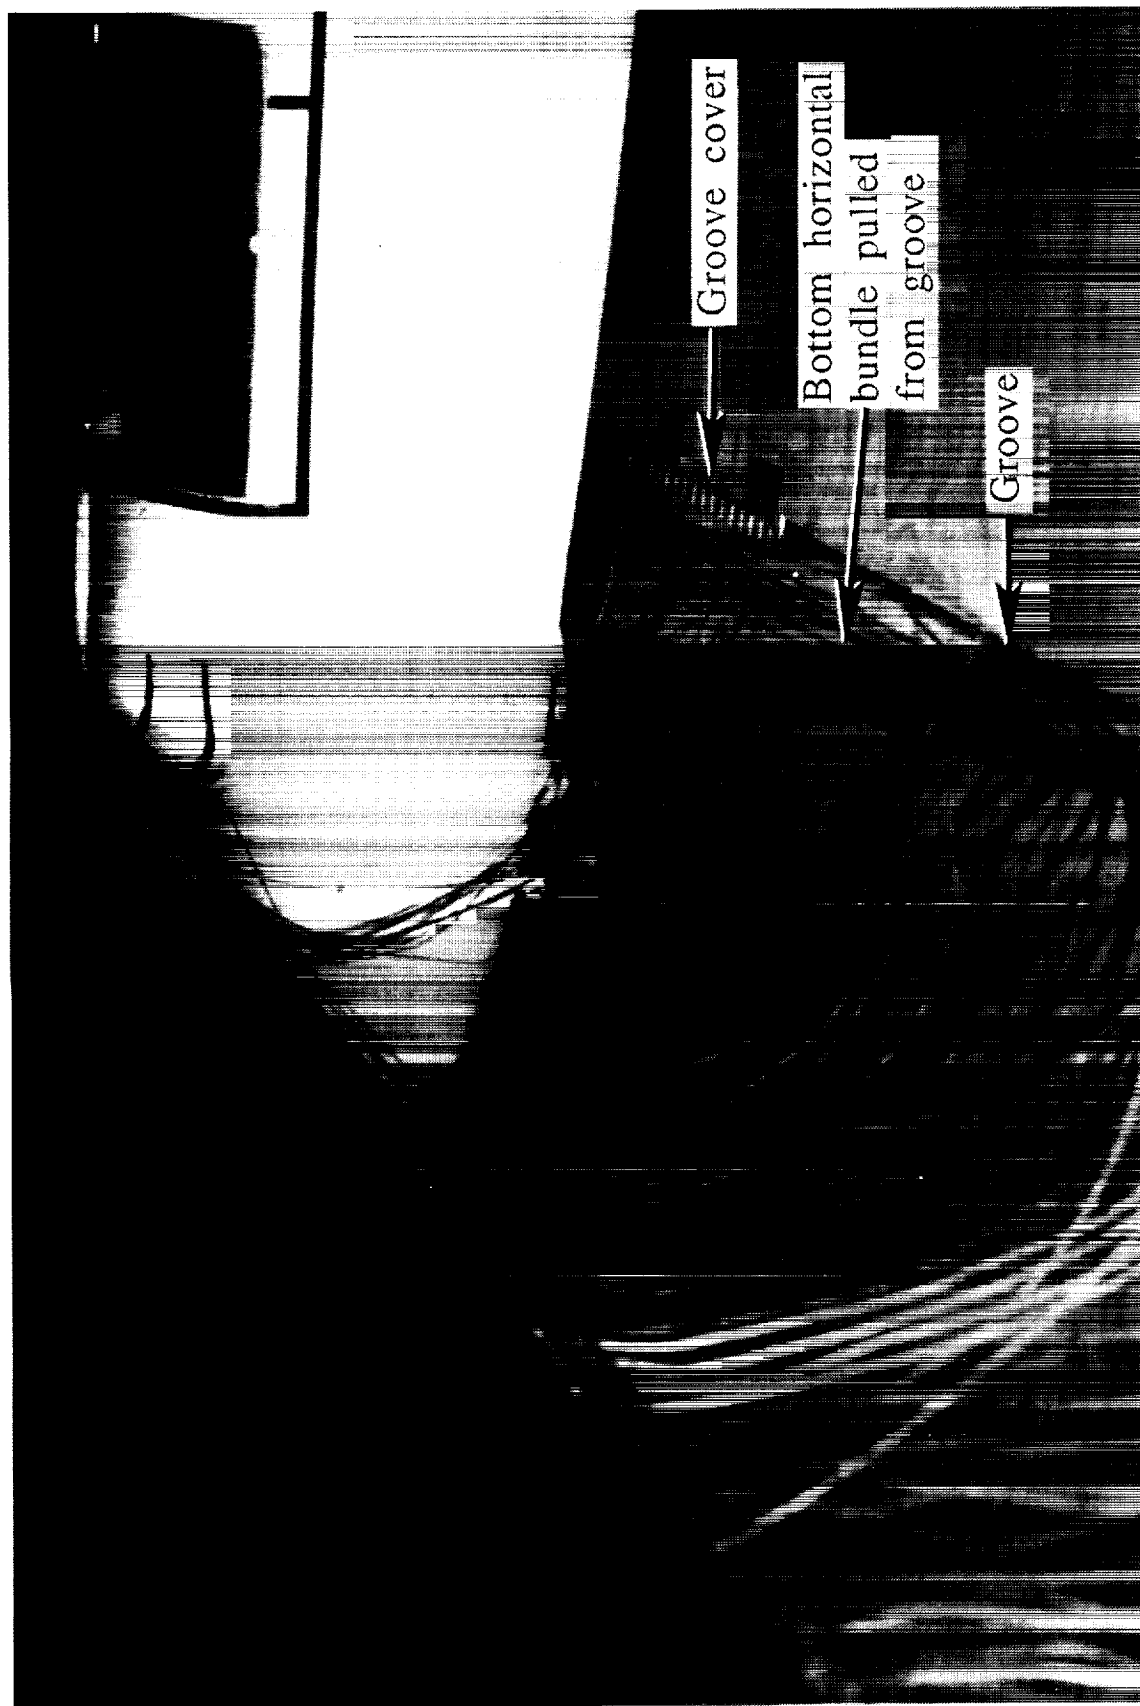
L-87-04684

(a) Side view.

Figure 20. Groove cut into runway surface to recess lower net bundle.

(b) Front view.

The solid rubber tires used in the model tests did not absorb the shock of hitting the bundle of net members like the actual orbiter inflated tires and thus did not properly respond to this bump input force. To conduct tests to determine whether vertical net members caught on the nose gear could cause nose gear failure, a groove was cut in the runway (fig. 20) to recess the lower horizontal bundle until the nose gear passed over it. The vertical net members were still exposed to being caught on the nose gear. As the net enveloped the model, the lower bundle was pulled out of the groove. For net 1, the nose gear did not fail during this test procedure.

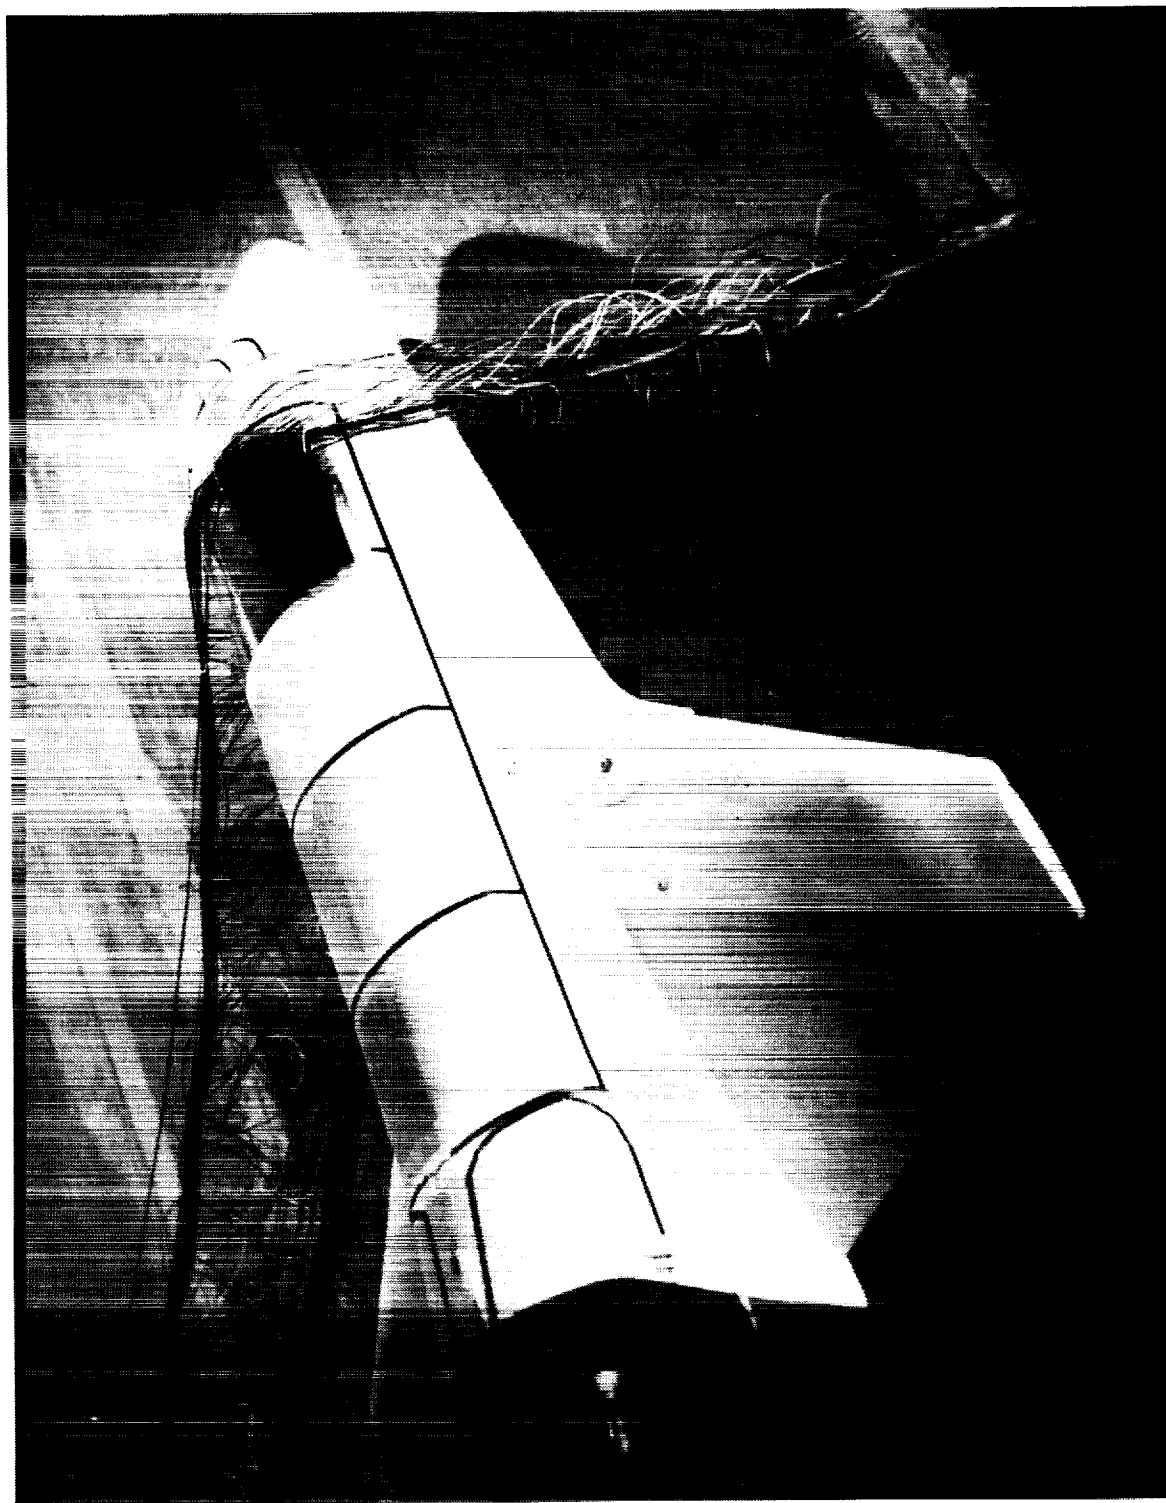
L-87-1102

Figure 32. Overstrength net caught on nose landing gear resulted in net staying on nose instead of enveloping wing.

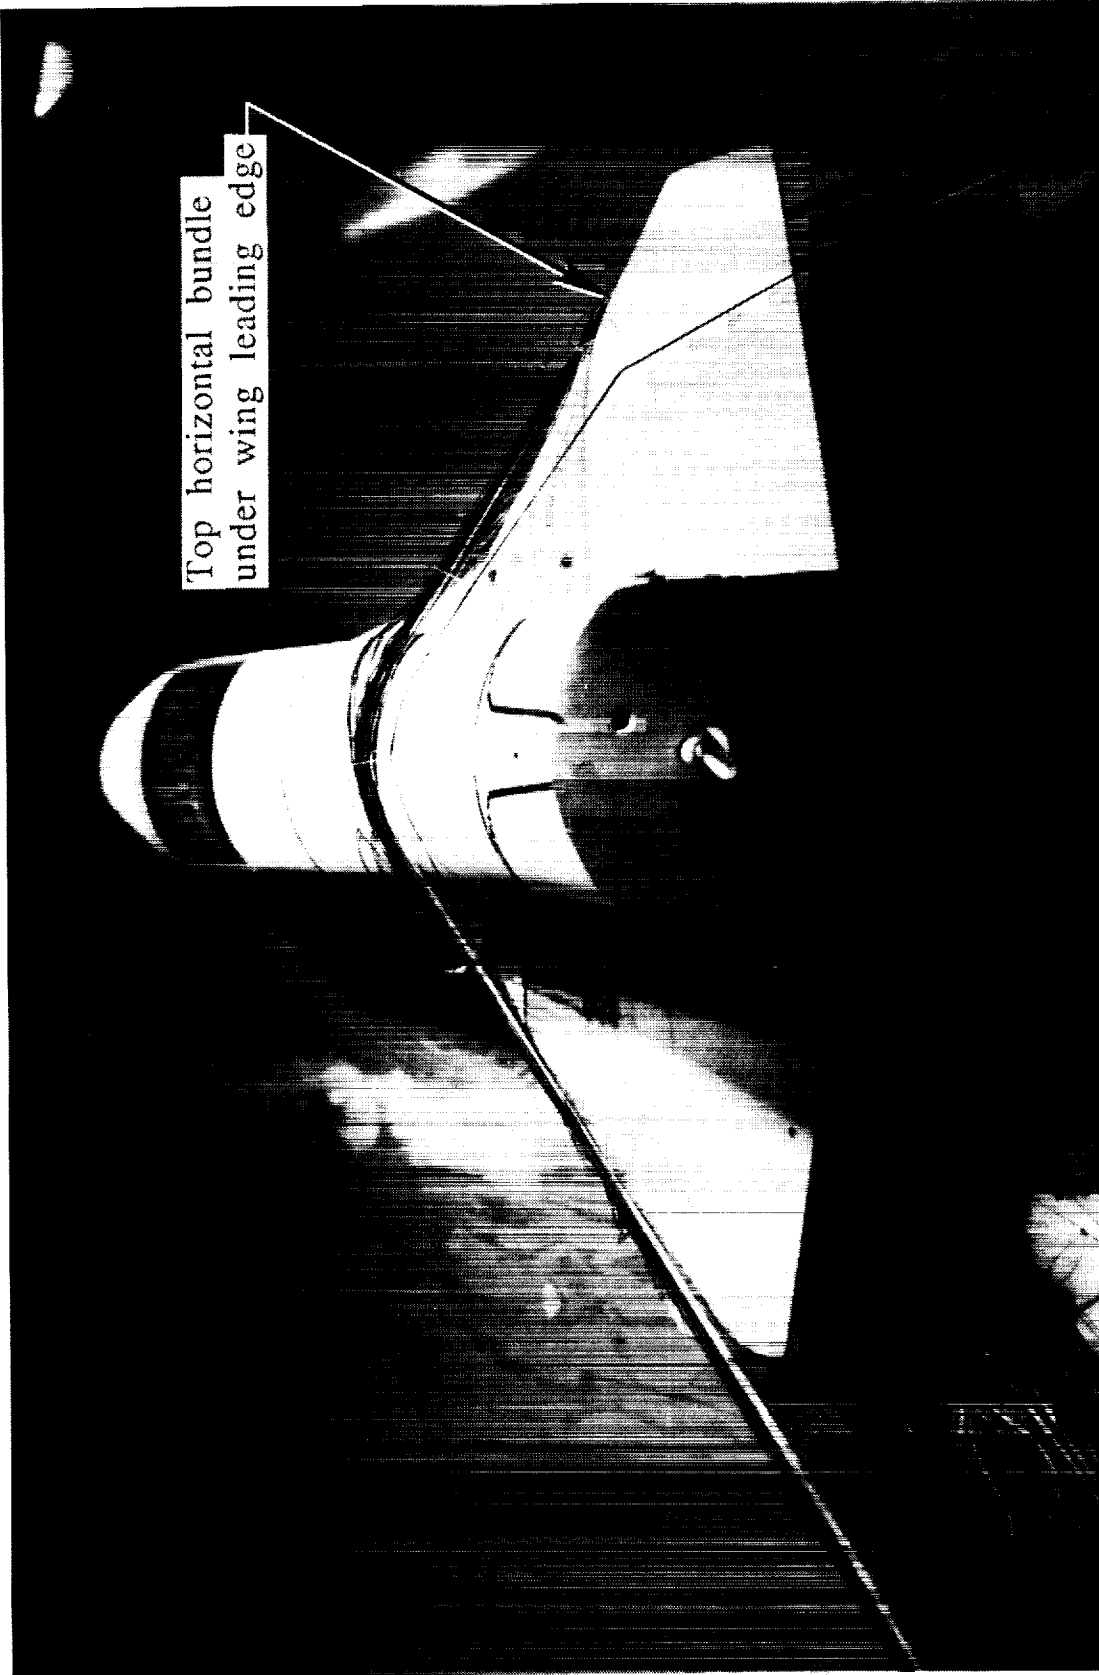
L-87-9143

Figure 34. Example of underwing engagement.

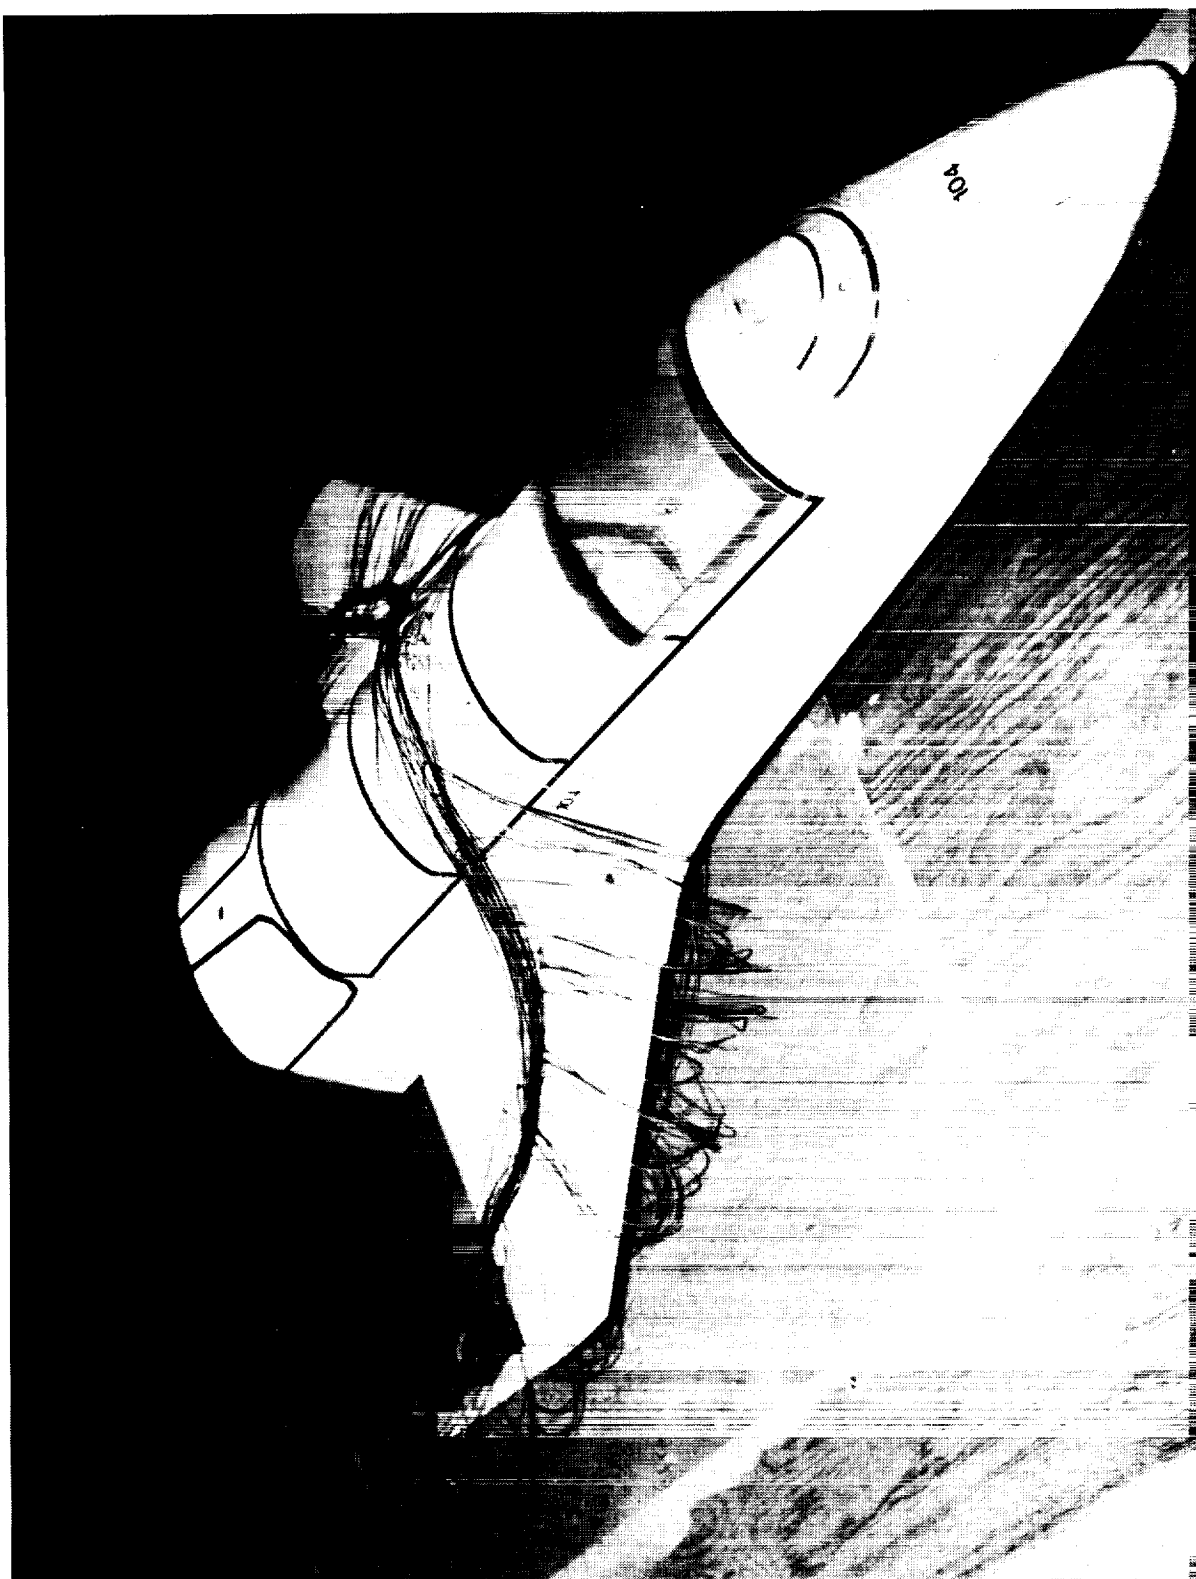
Figure 35. Typical good wing envelopment by net.

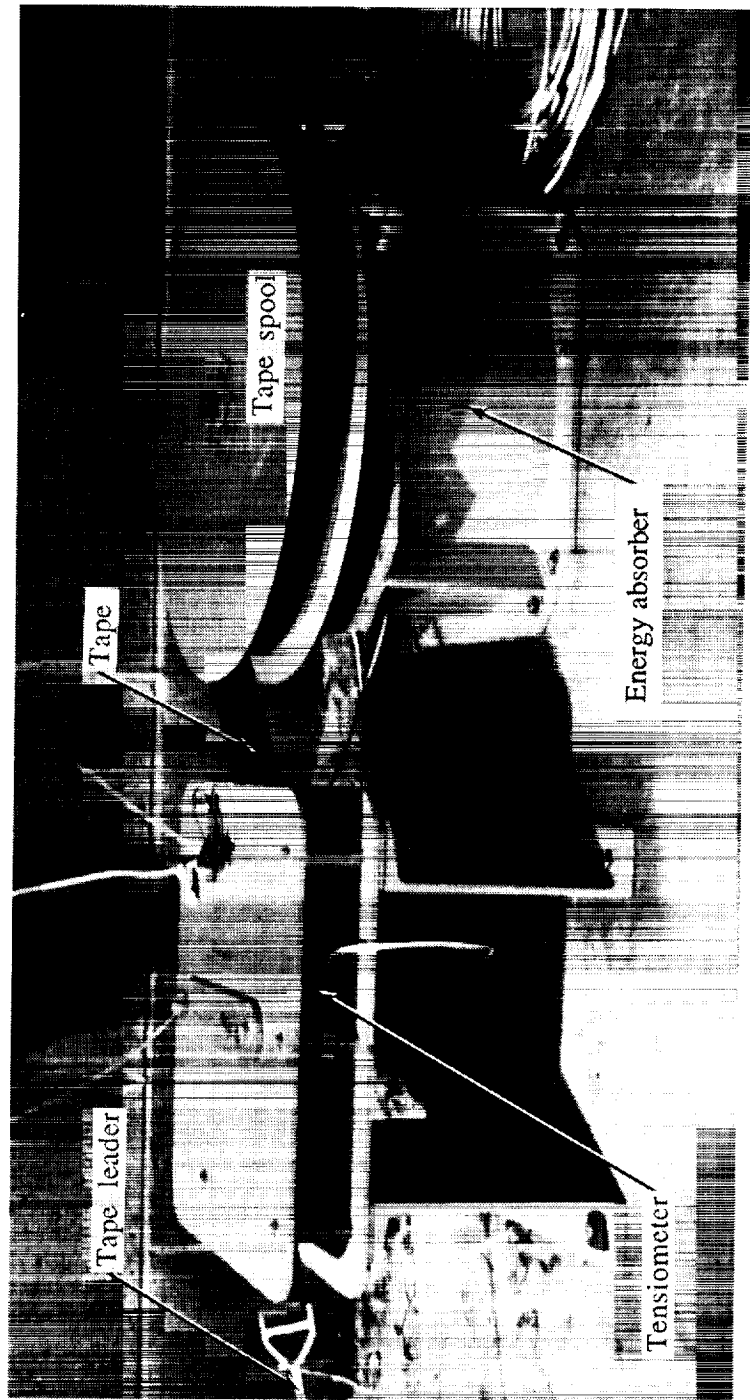
L-93-58

Figure A9. 14-in-diameter energy absorber used in 1/8-scale model test.

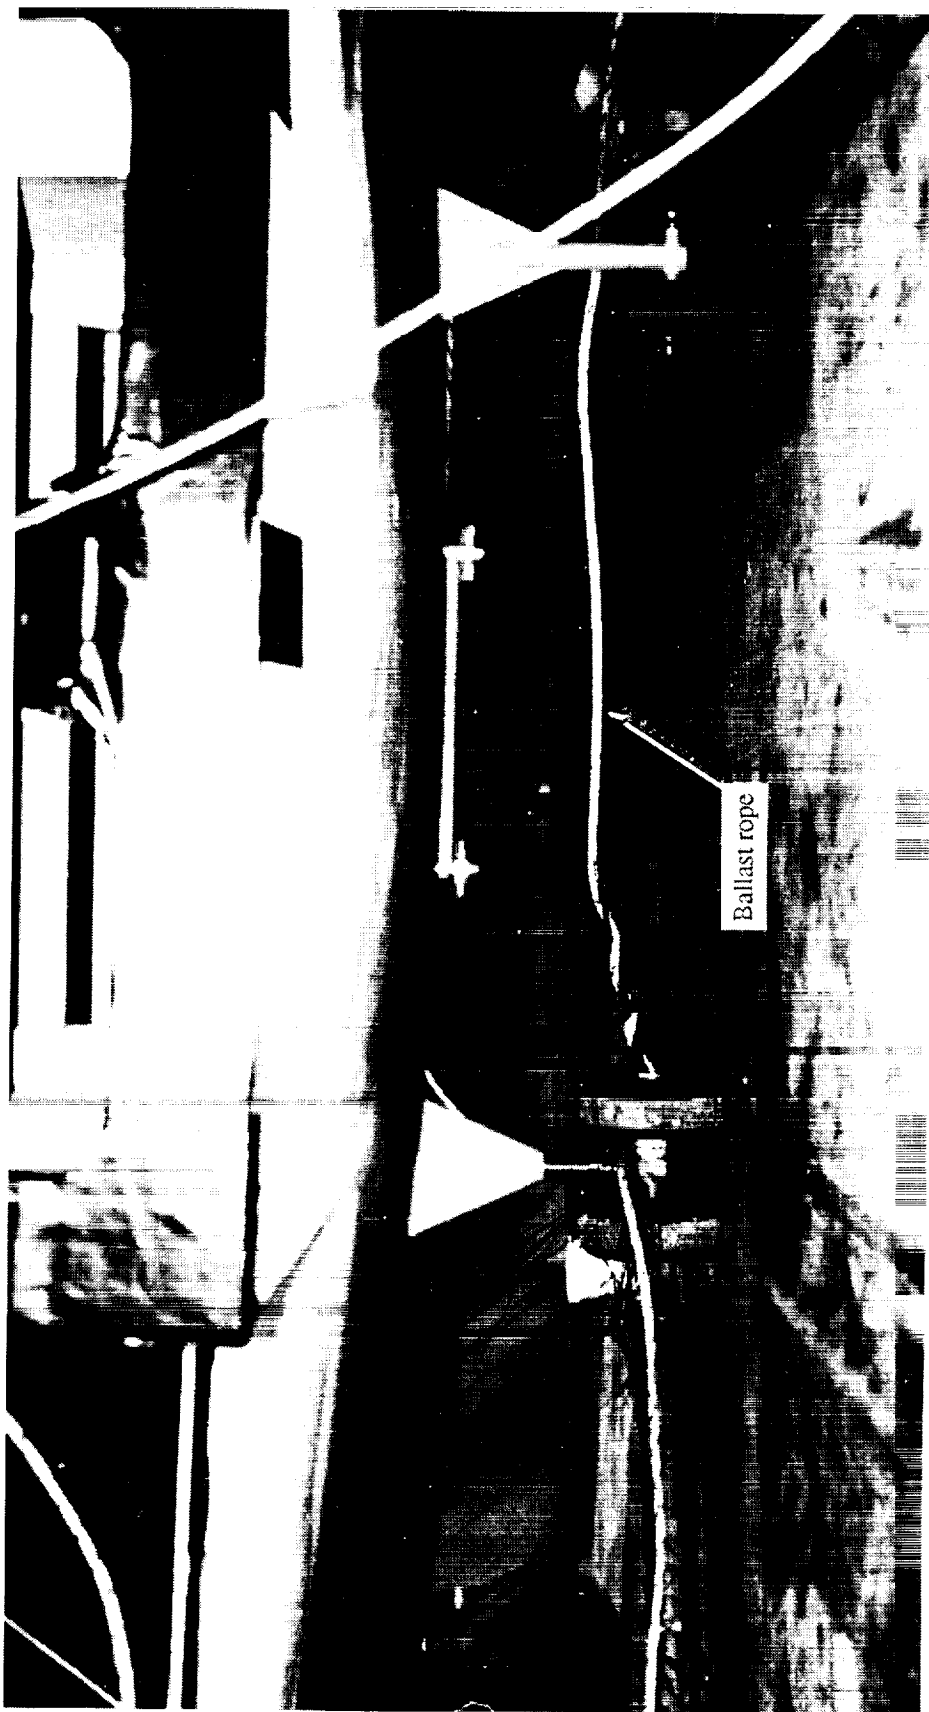
L-93-60

Figure A13. Lower horizontal bundle and lower ballast rope entanglement of main gear.
